Limited Visual Dam Safety Inspection Summary Report

MA-076

Maui Reservoir 33

Limited Visual Dam Safety Inspection Conducted on: 03 April 2006

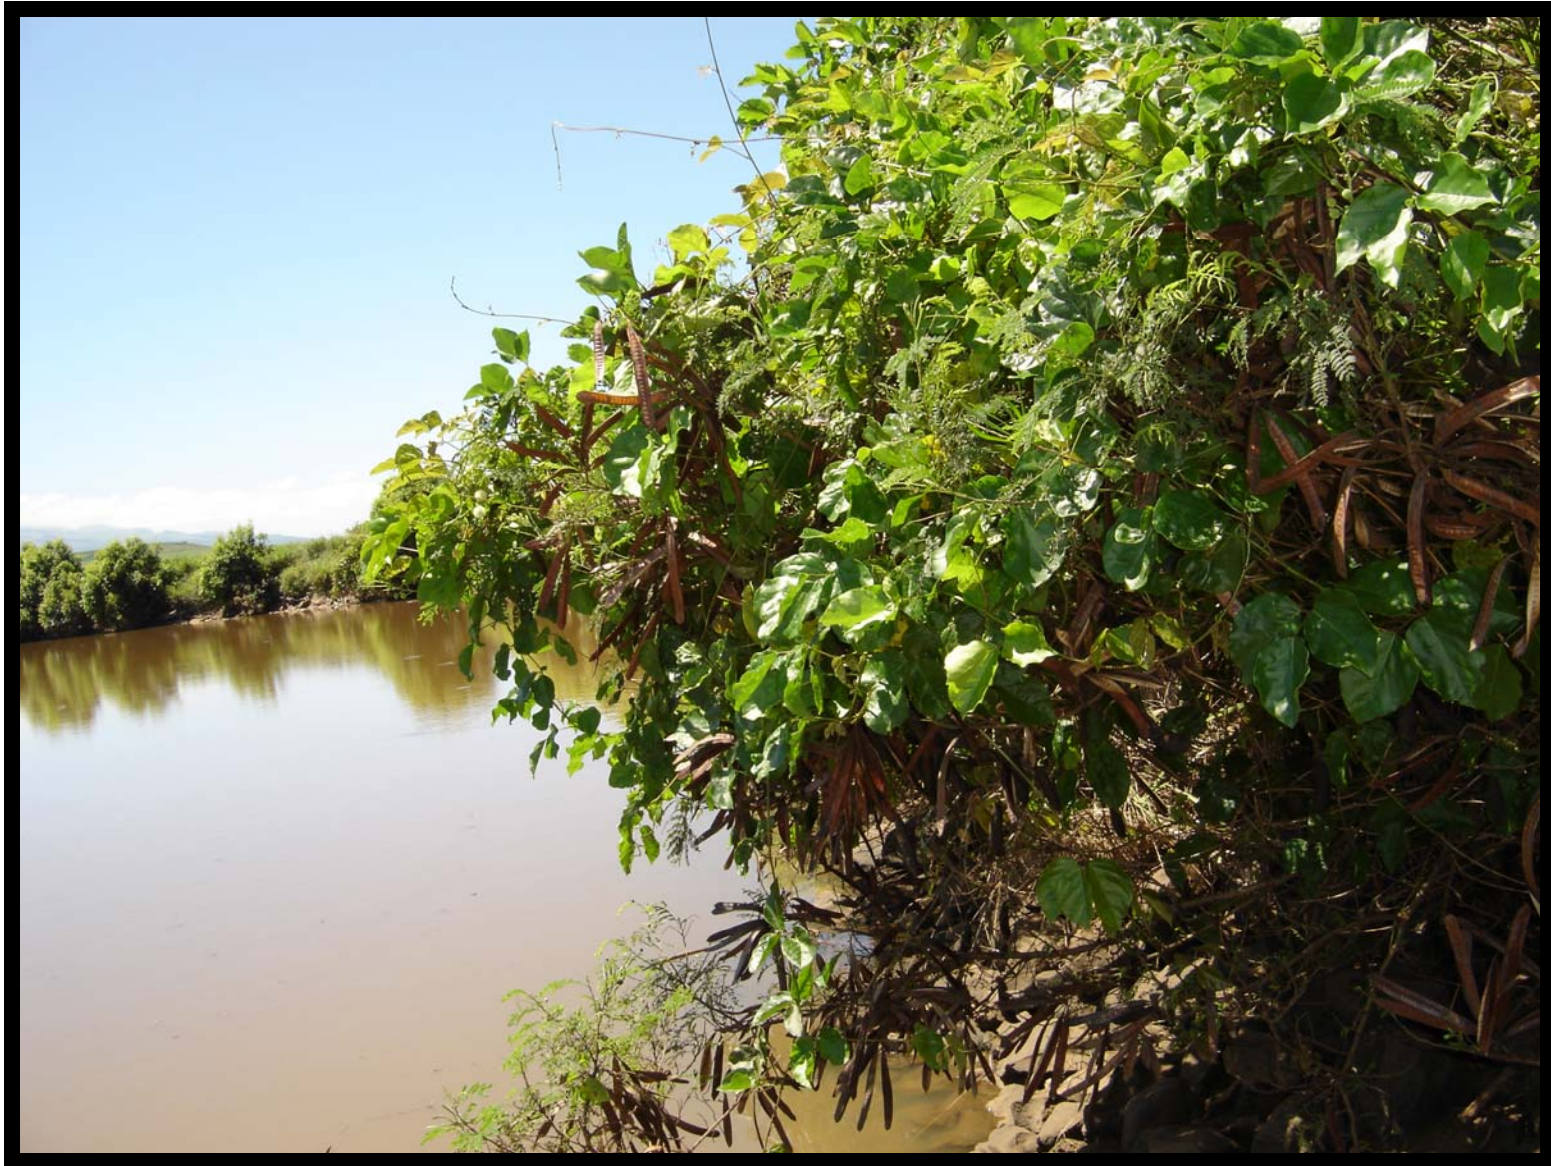
076 View of right end crest that was heavily overgrown with trees and brush

- a. The dam crest appeared to be in fair to poor condition and requires corrective action. There is heavy overgrowth of vegetation that should be removed to facilitate inspection.
- b. Access along the crest was difficult due to vegetation overgrowth.
- c. Portions were not visible due to high grass and bush visual inspection. Clear high vegetation and maintain low to enable easy visual inspection.
- d. Tree(s) were observed on the dam embankment. Trees have been identified as the probable cause of piping failures, and can possibly cause severe damage to the embankment if they are uprooted during high winds. Corrective action is required to remove the tree hazards from the dam. Acceptable remedies include removal of the tree and its root structure down to a 2" diameter and

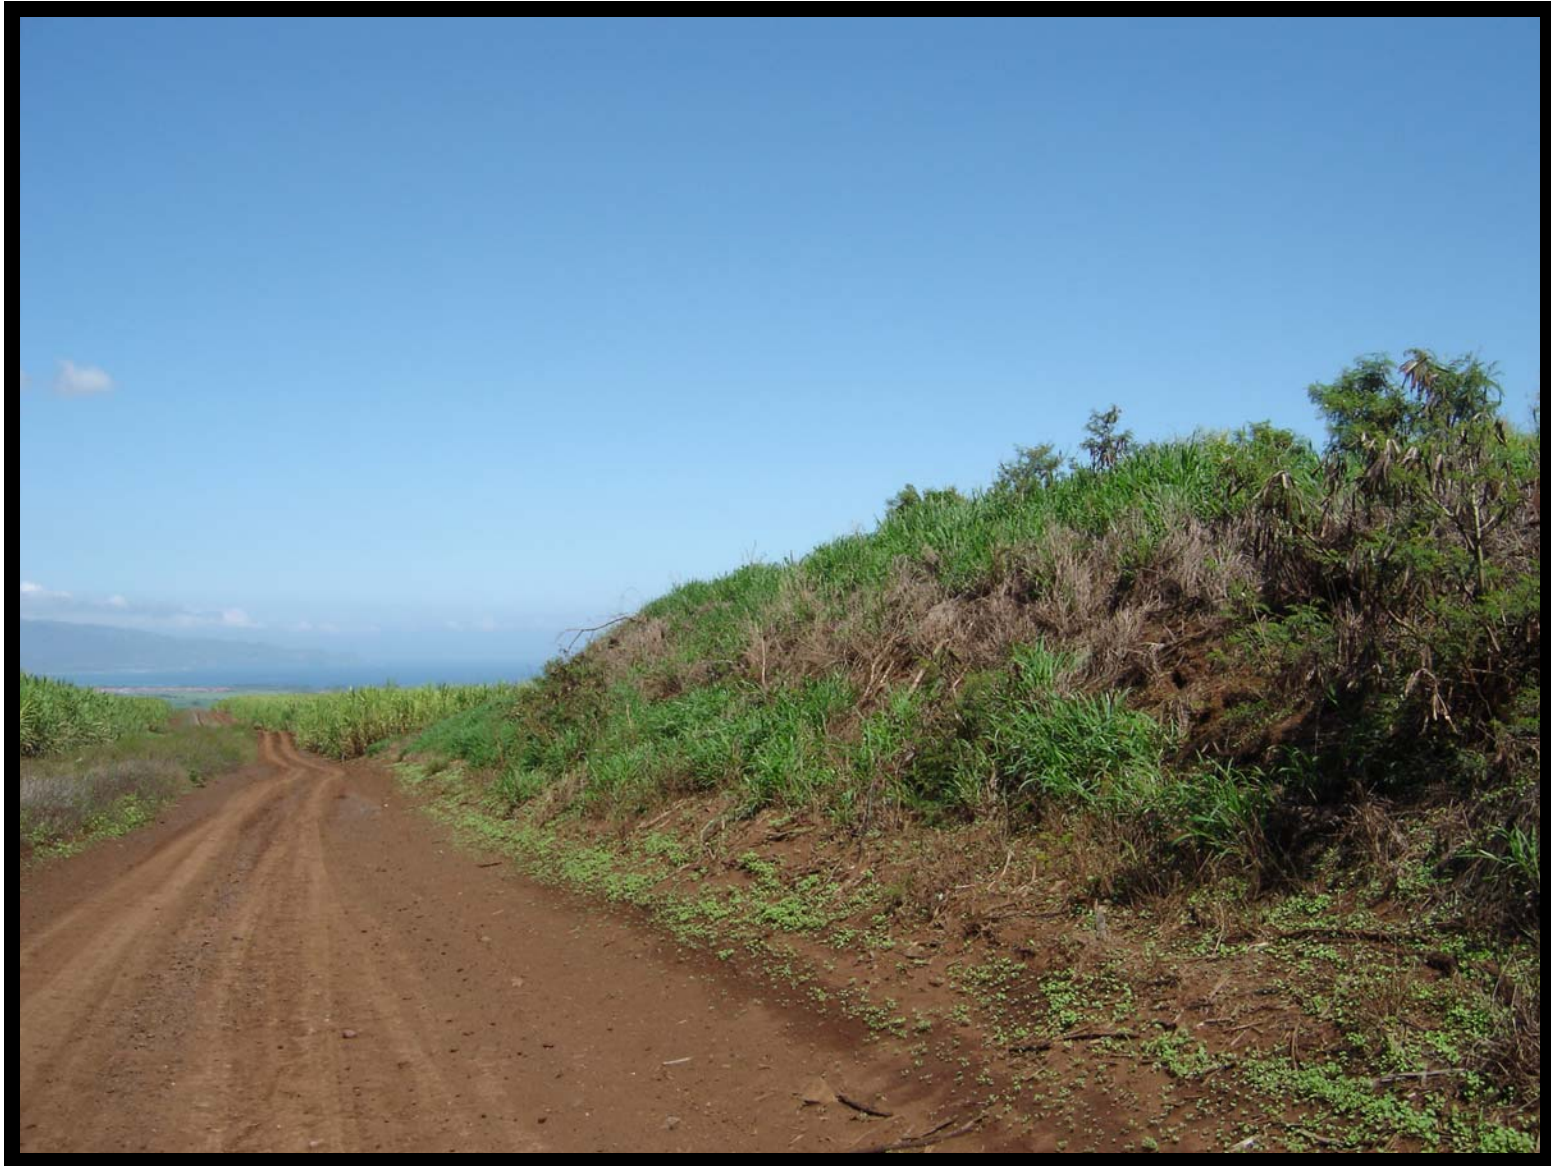
076 View of downstream slope and ground cover for left embankment

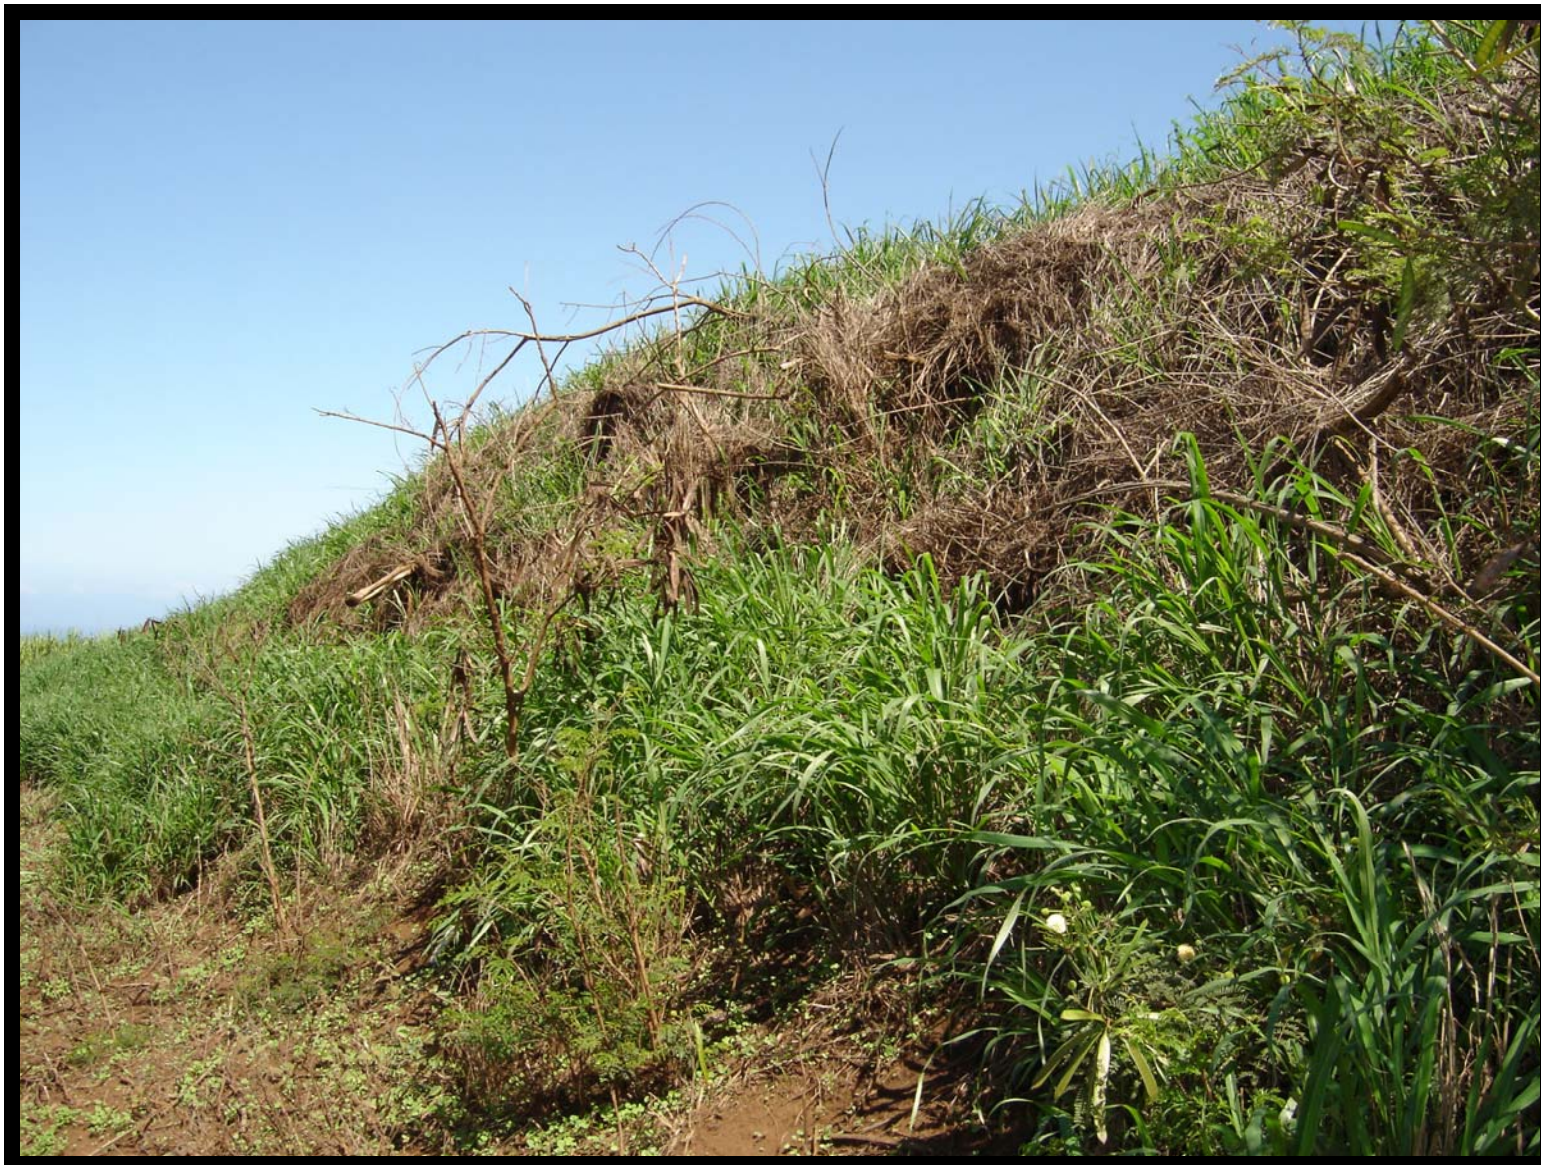
076 View of downstream slope and ground cover for left embankment

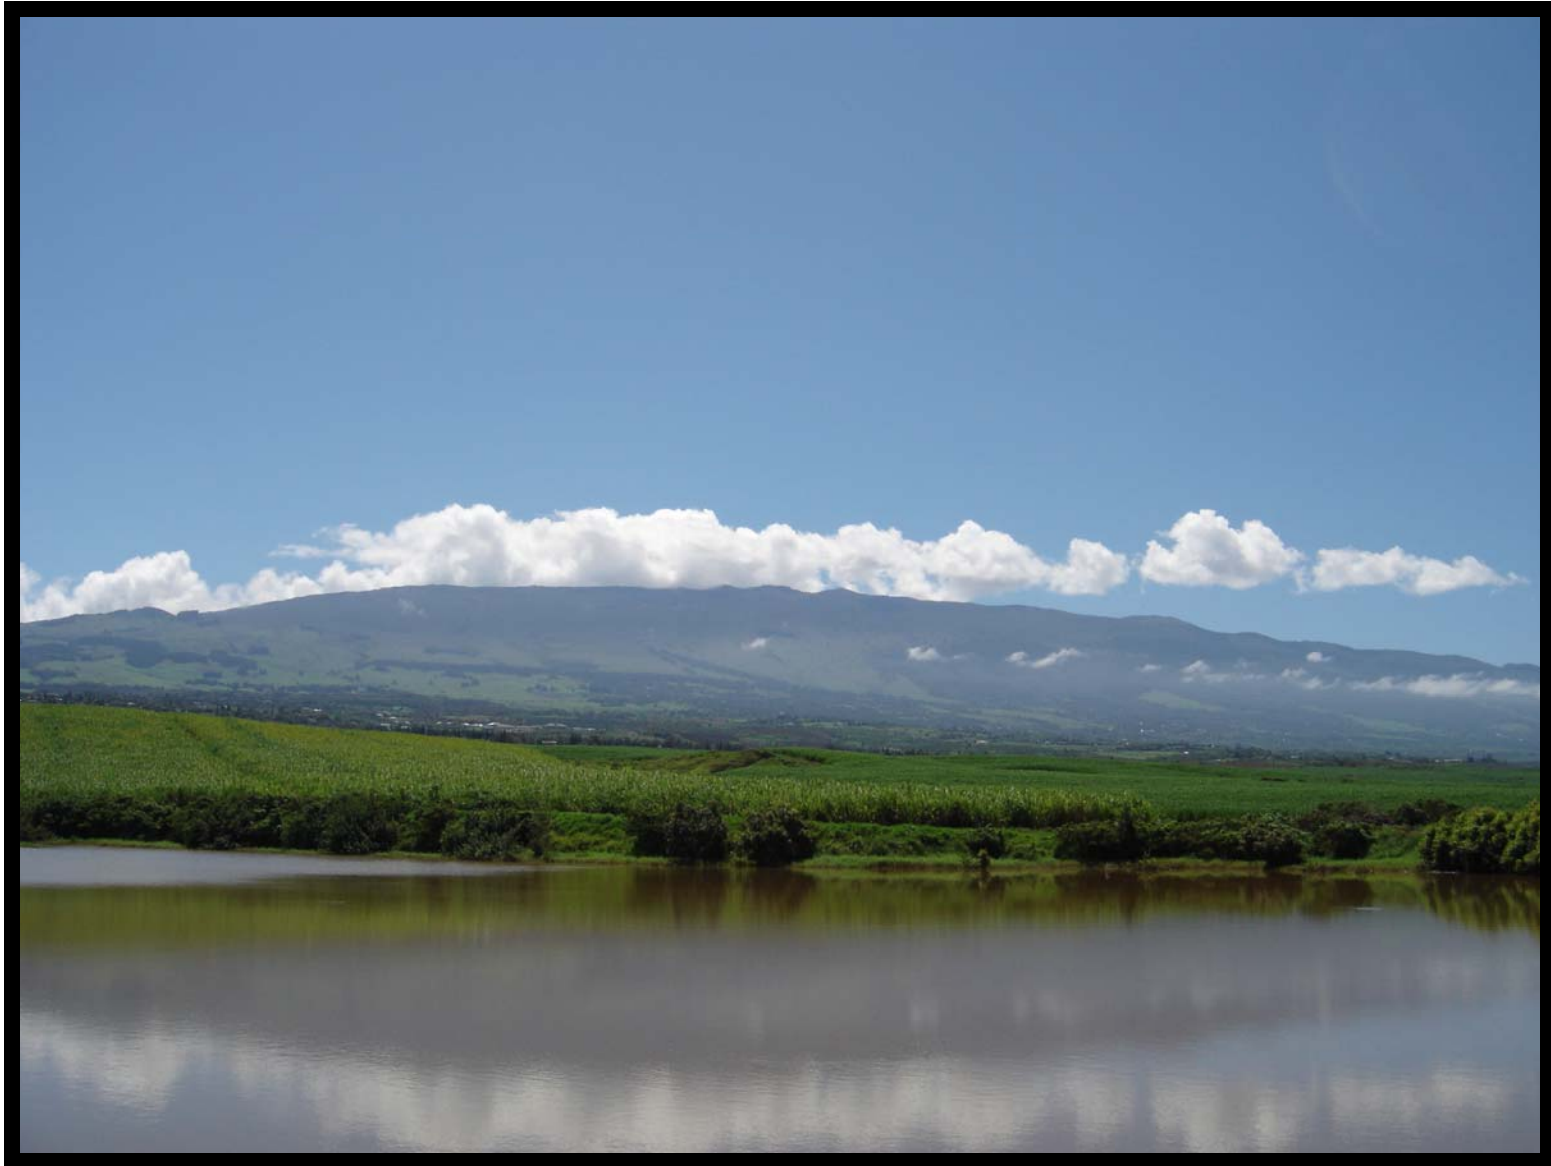
076 View of upslope trees growth and overgrowth of left embankment

- a. The reservoir appeared to be in fair to poor condition and requires corrective action. Remove overgrowth.
- b. The upstream slope was not visible due to high grass and bush visual inspection. Clear high vegetation and maintain low to enable easy visual inspection.
- c. Tree(s) were observed on the dam embankment. Trees have been identified as the probable cause of piping failures, and can possibly cause severe damage to the embankment if they are uprooted during high winds. Corrective action is required to remove the tree hazards from the dam. Acceptable remedies include removal of the tree and its root structure down to a 2" diameter and reconstruction the damaged embankment section. All repair work shall be accomplished as per the requirements of licensed geotechnical or structural engineer. Routinely monitor the damaged area for signs of settlement and seepage.

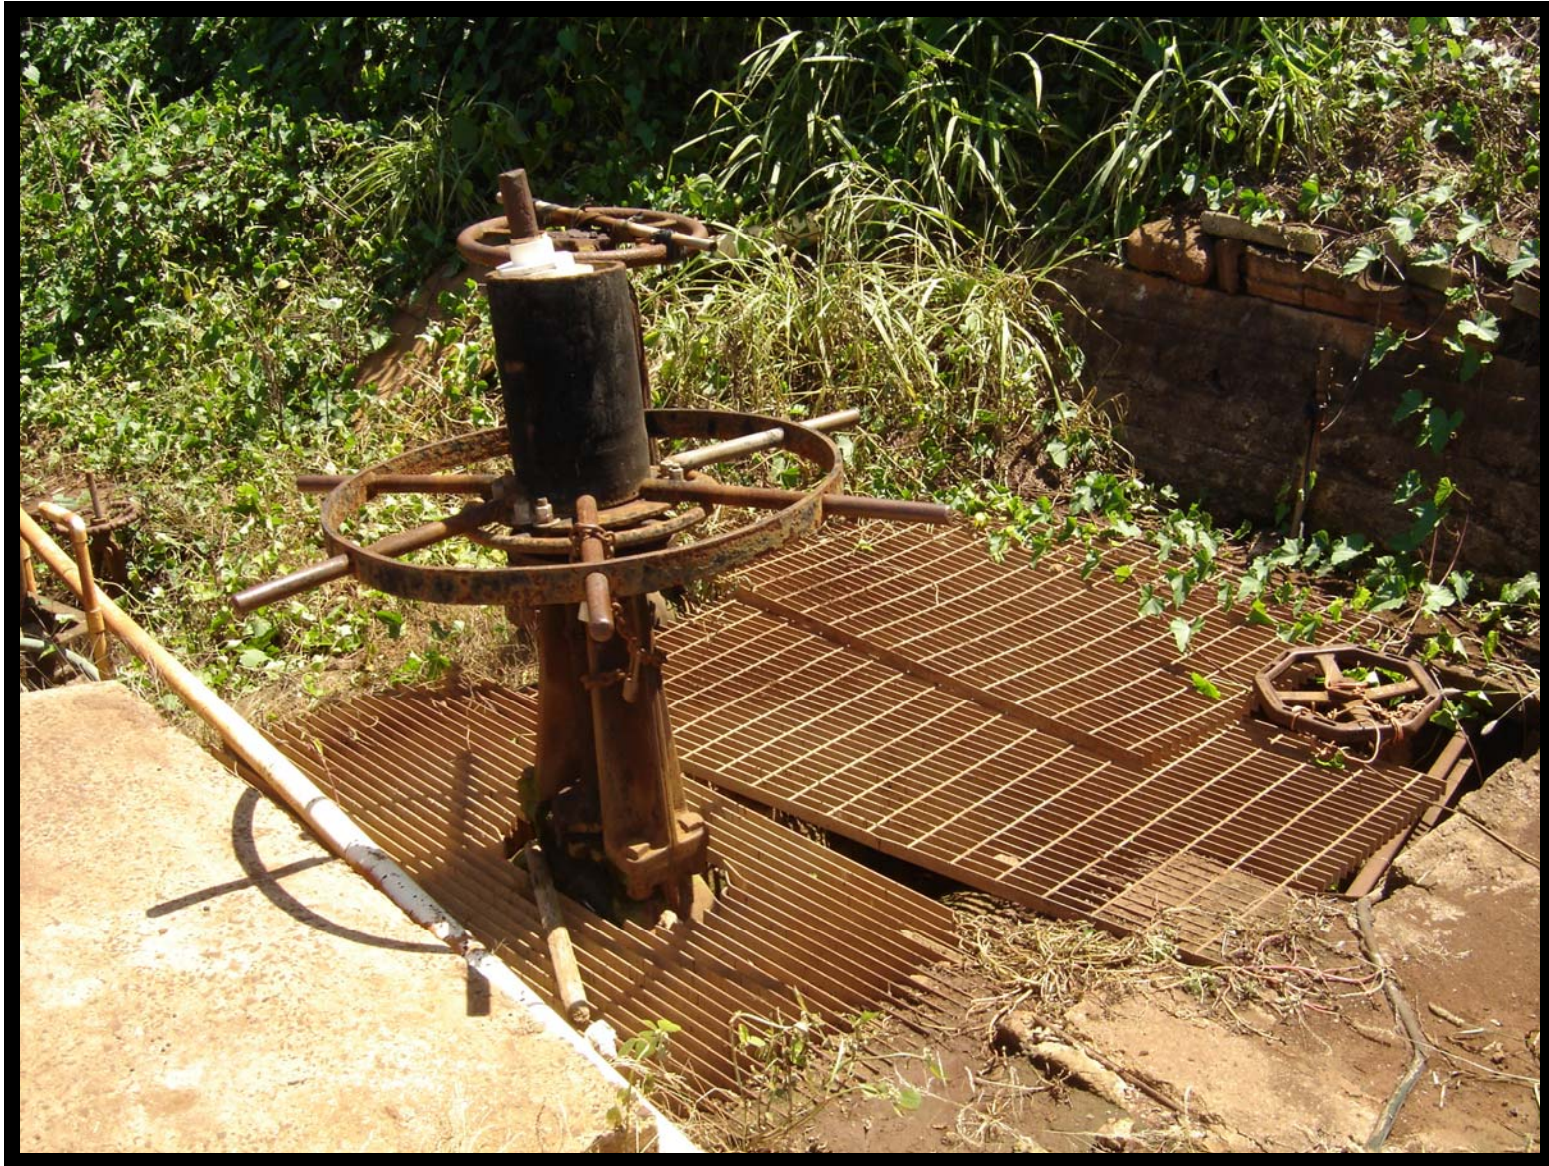
076 View of outlet valve (working) at DS toe and diversion channel

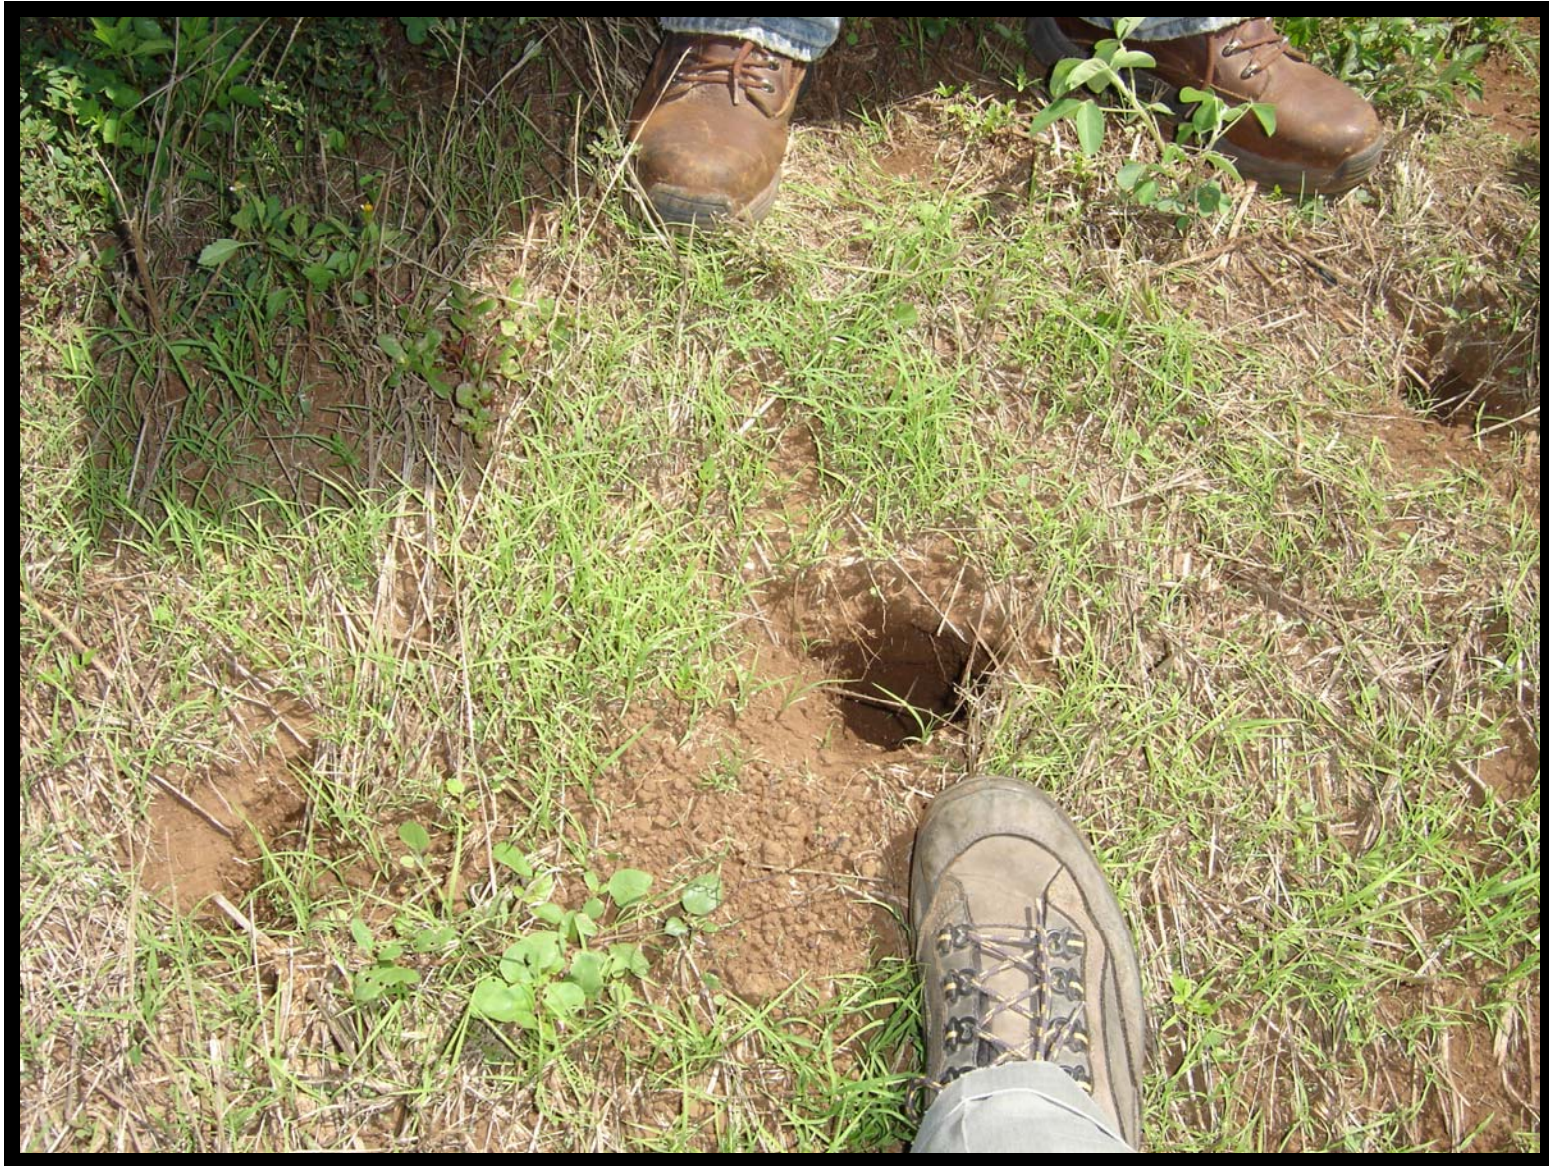
076 View of possible animal burrow on right embankment crest

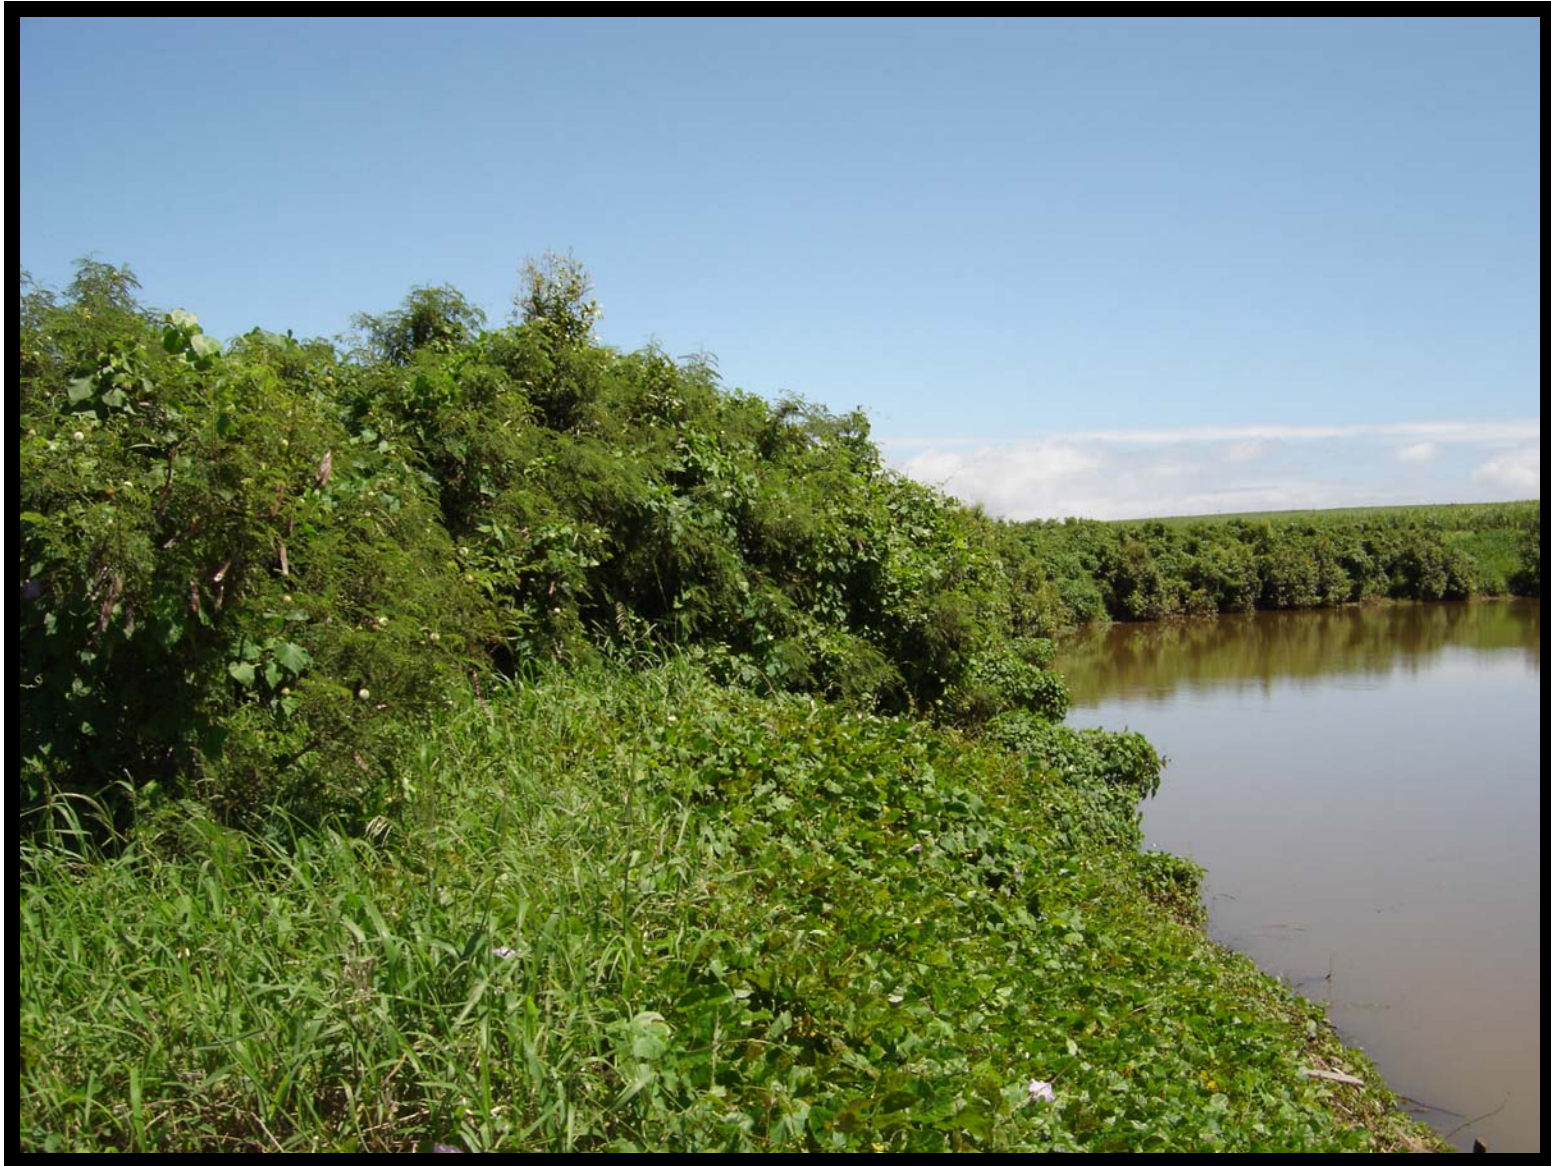
076 Right Crest - View of inaccessible right end crest that was heavily overgrown

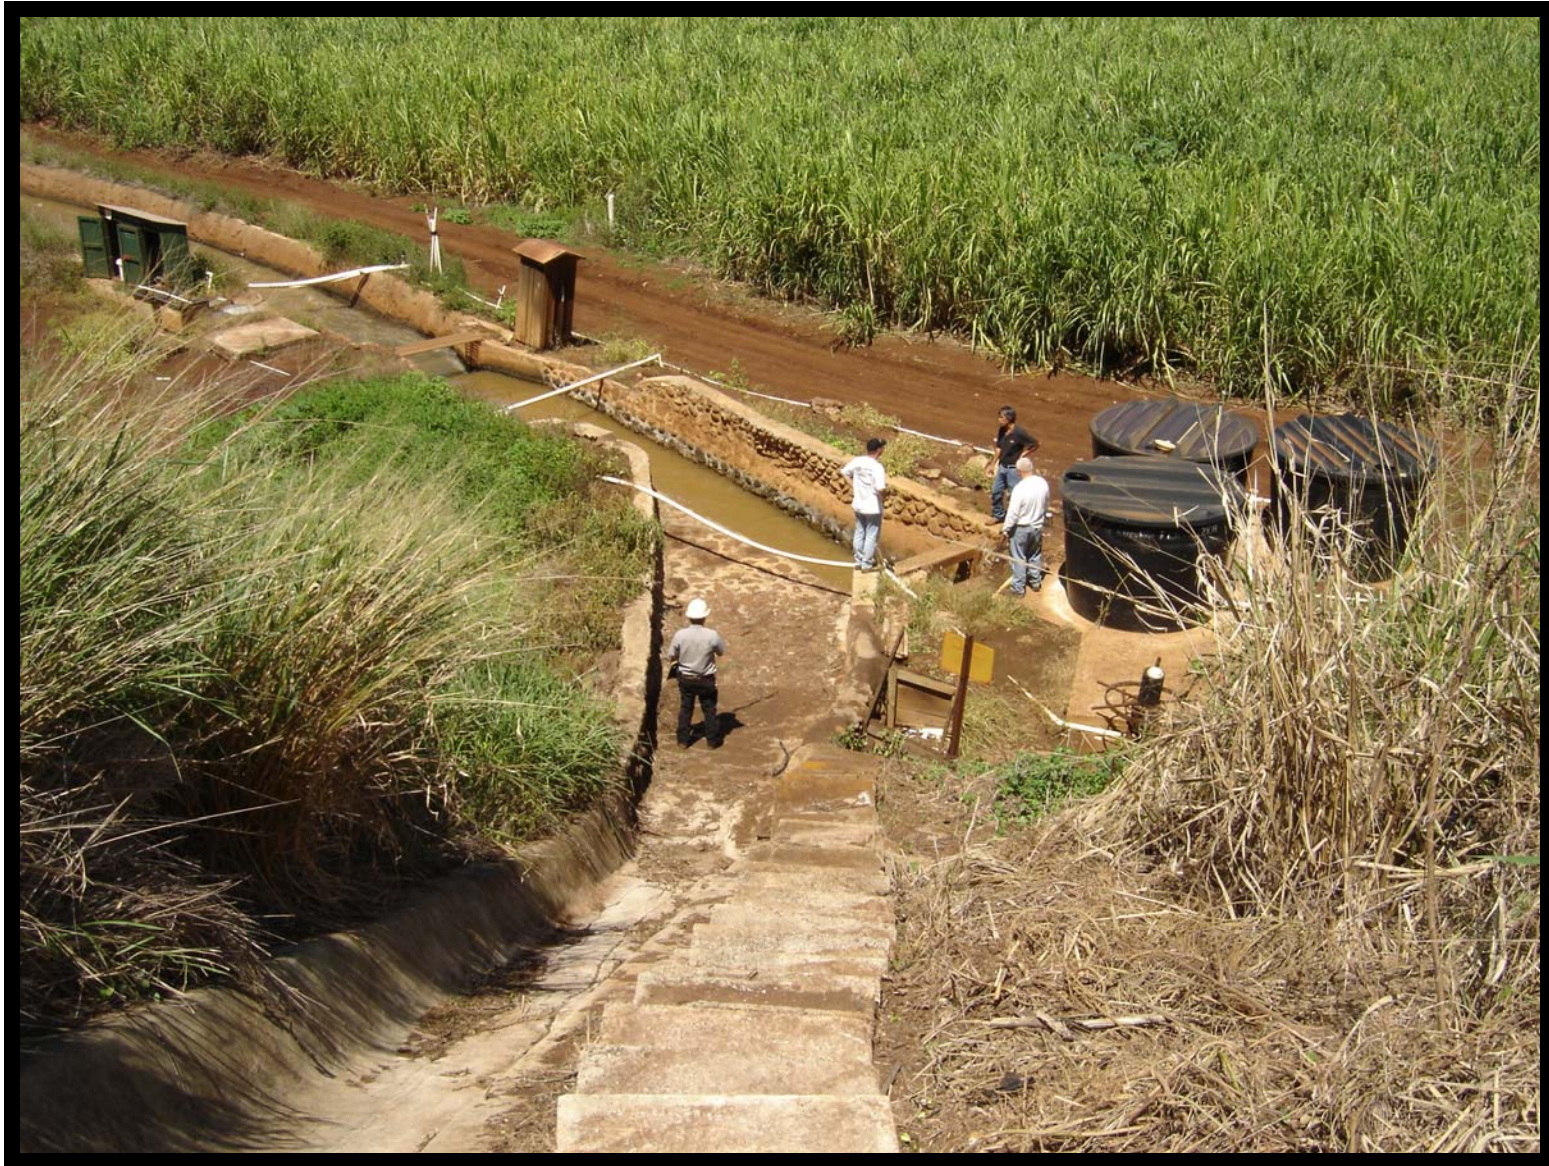
076 Spillway and Outlet Works - View of spillway flume DS and adjacent outlet works/diversion

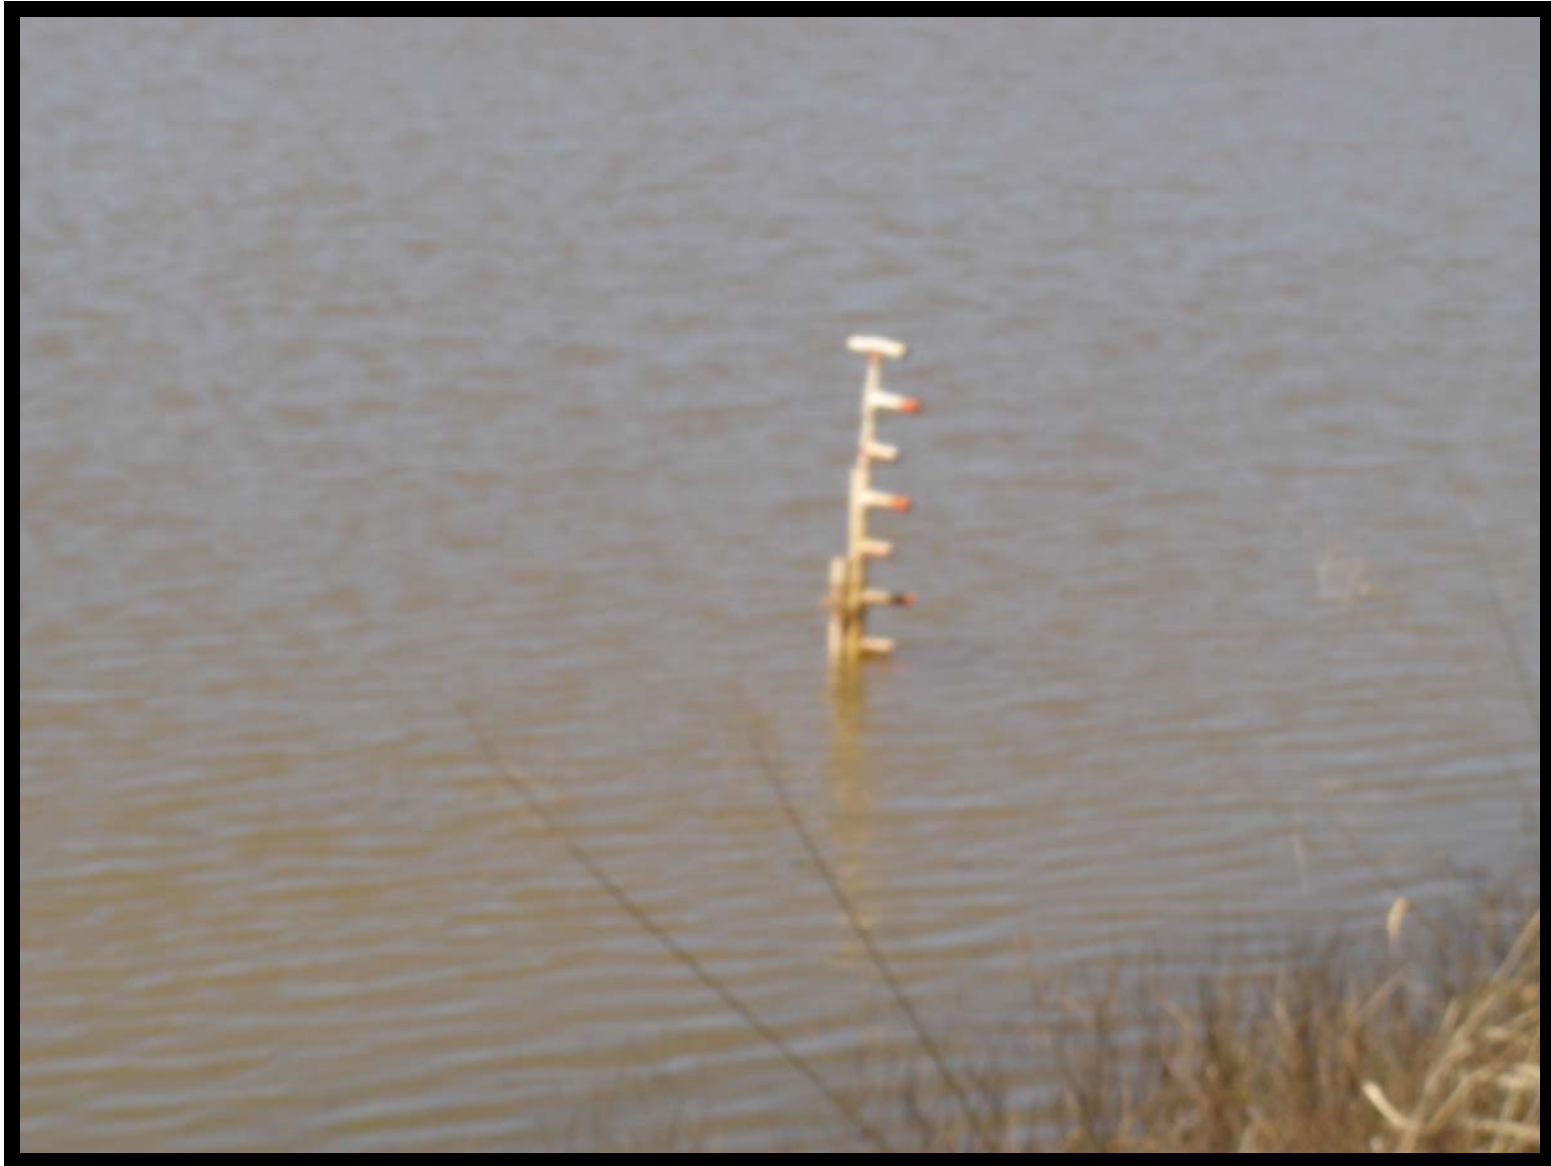
076 staff gage located near right downstream end of reservoir

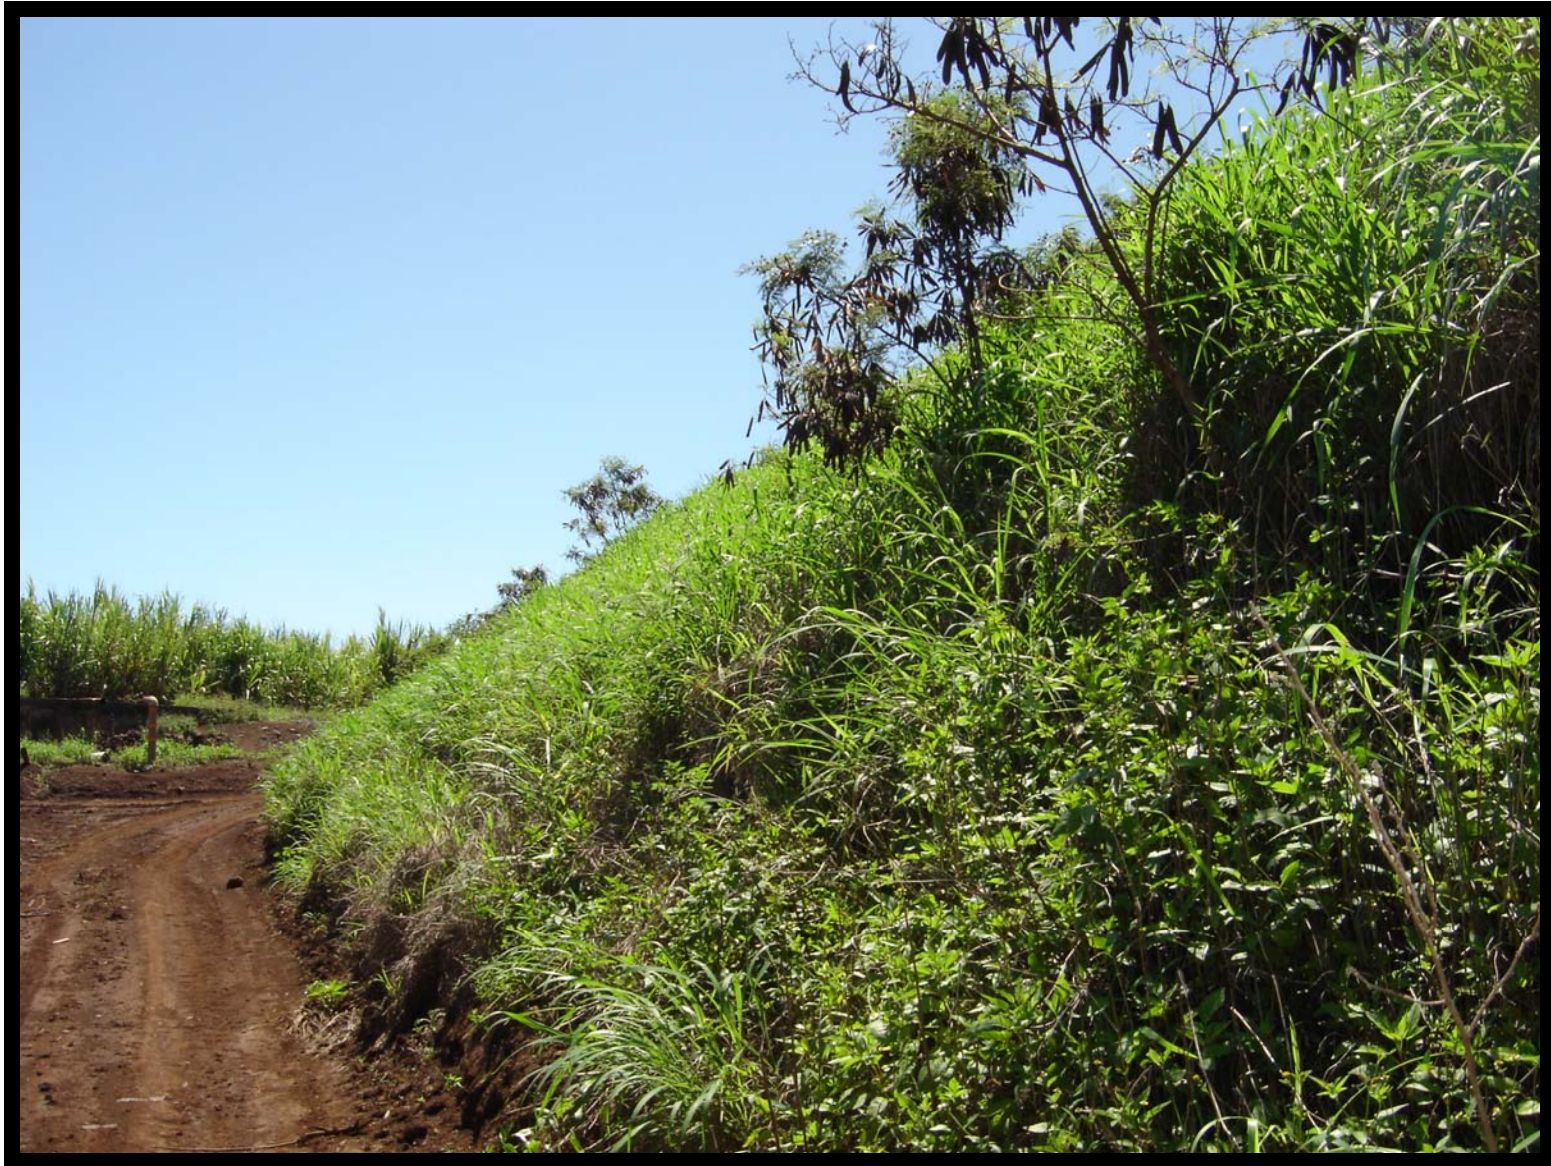
076 Downstream Slope - downstream slope angle near right embankment.
